S19-941

Wyberton West Road & Park Road, Boston

Section 19 Flood and Water
Management Act 2010

GeoSmart Information Ltd

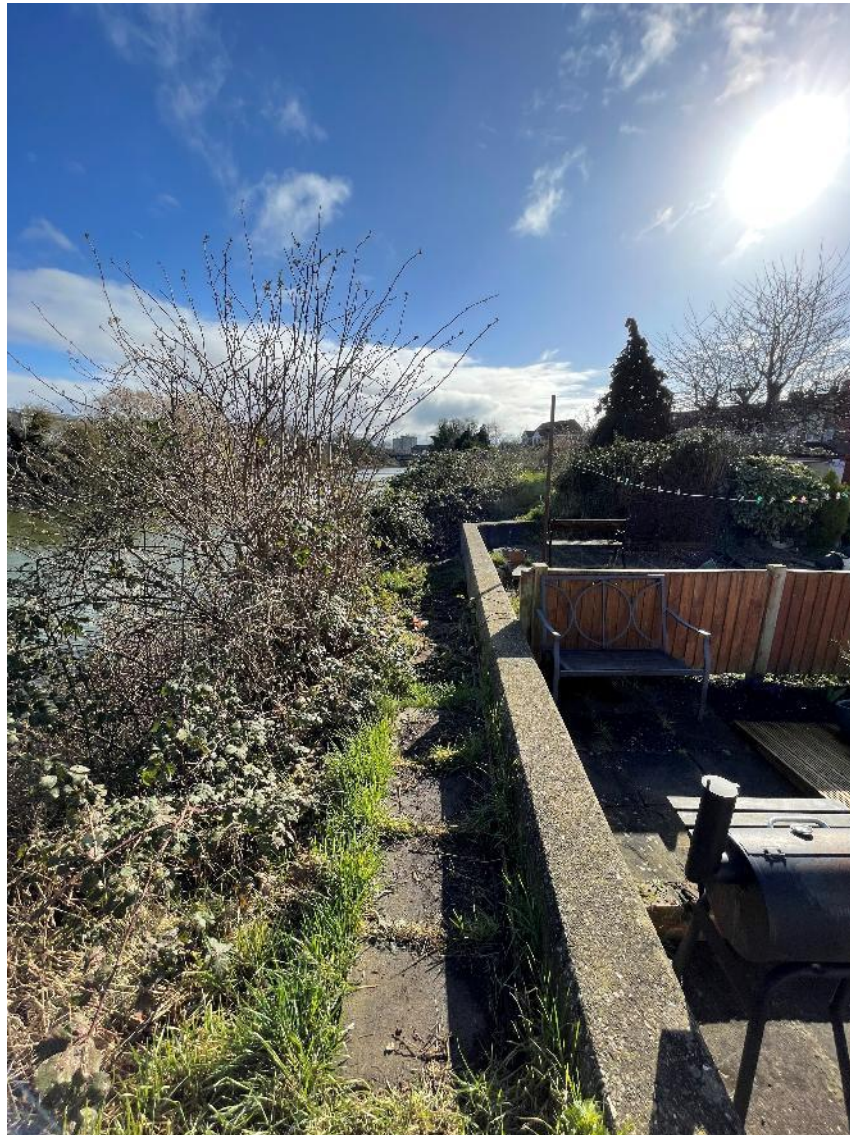
- Two sections of flood walls are located adjacent to Properties B to F and P to U, with effective crest levels between 2.80 and 2.88 mAOD (Photographs 1 to 3 in Appendix 7.3). These crest levels are validated by a post-incident flood wall survey undertaken by the EA as part of their review of the flood event (see Section 3.3). The defences are estimated to provide protection up to a 1 in 20 year (5% AEP) event and are recorded as having condition grades of 3 (‘fair’) to 4 (‘poor’);

(Photograph 1 – Western section of EA flood wall structure along the southern bank of the SFFD; facing east)

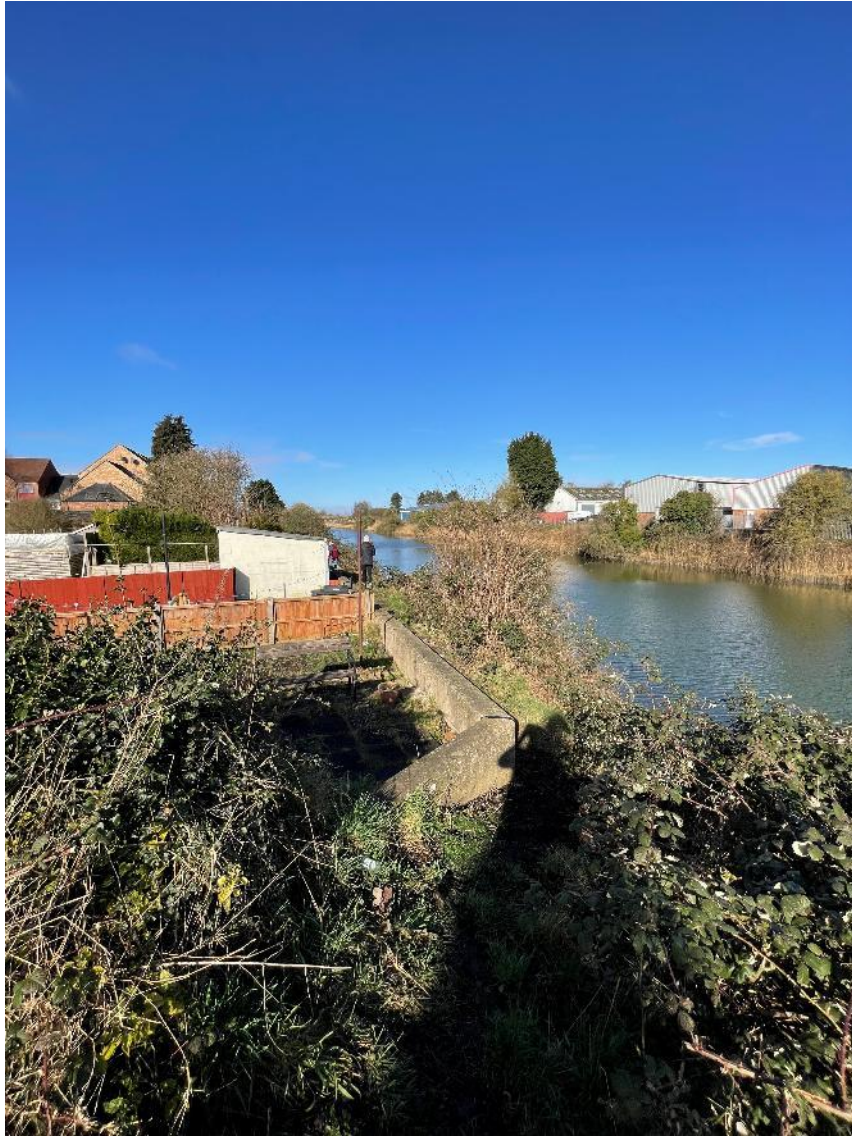
(Photograph 2 – Western section of EA flood wall along the southern bank of the SFFD; facing west)

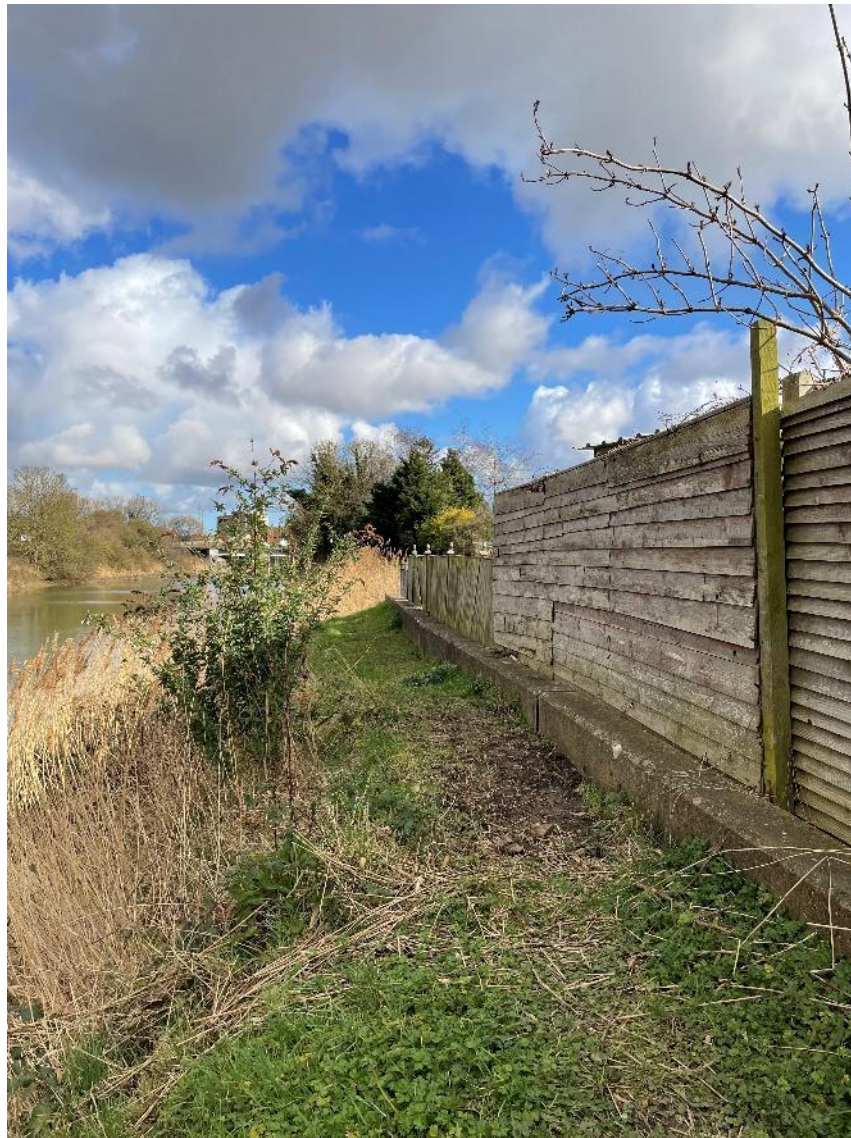
(Photograph 3 – Eastern section of EA flood wall along the southern bank of the SFFD; facing east)
