**S19-941**

**Wyberton West  
Road & Park Road,  
Boston**

Section 19 Flood and Water  
Management Act 2010

GeoSmart Information Ltd

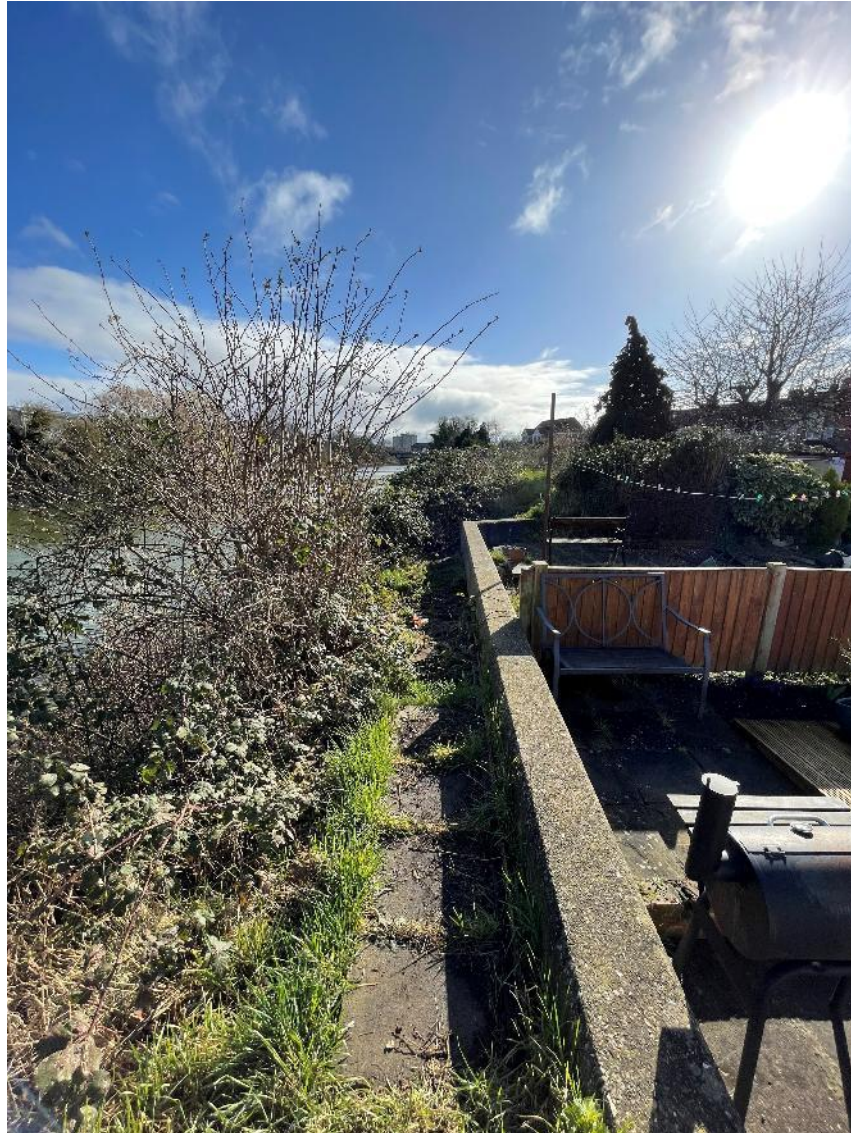
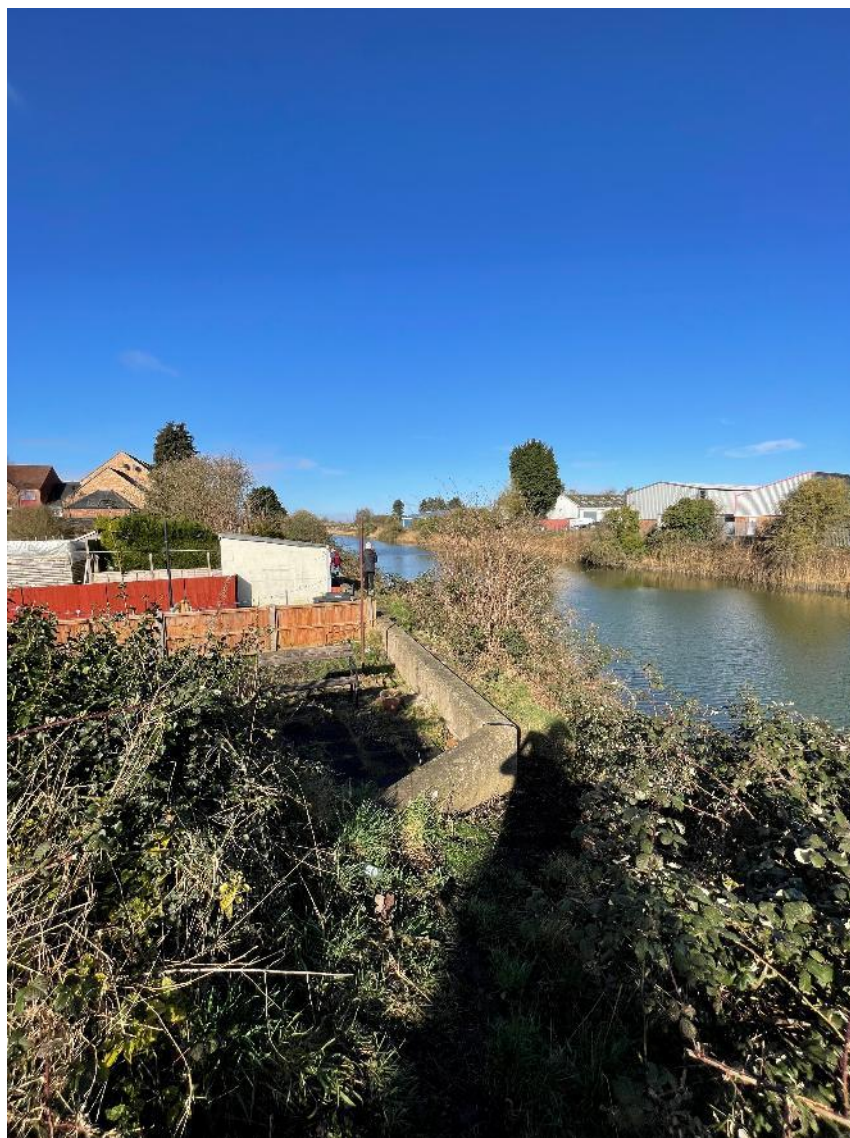
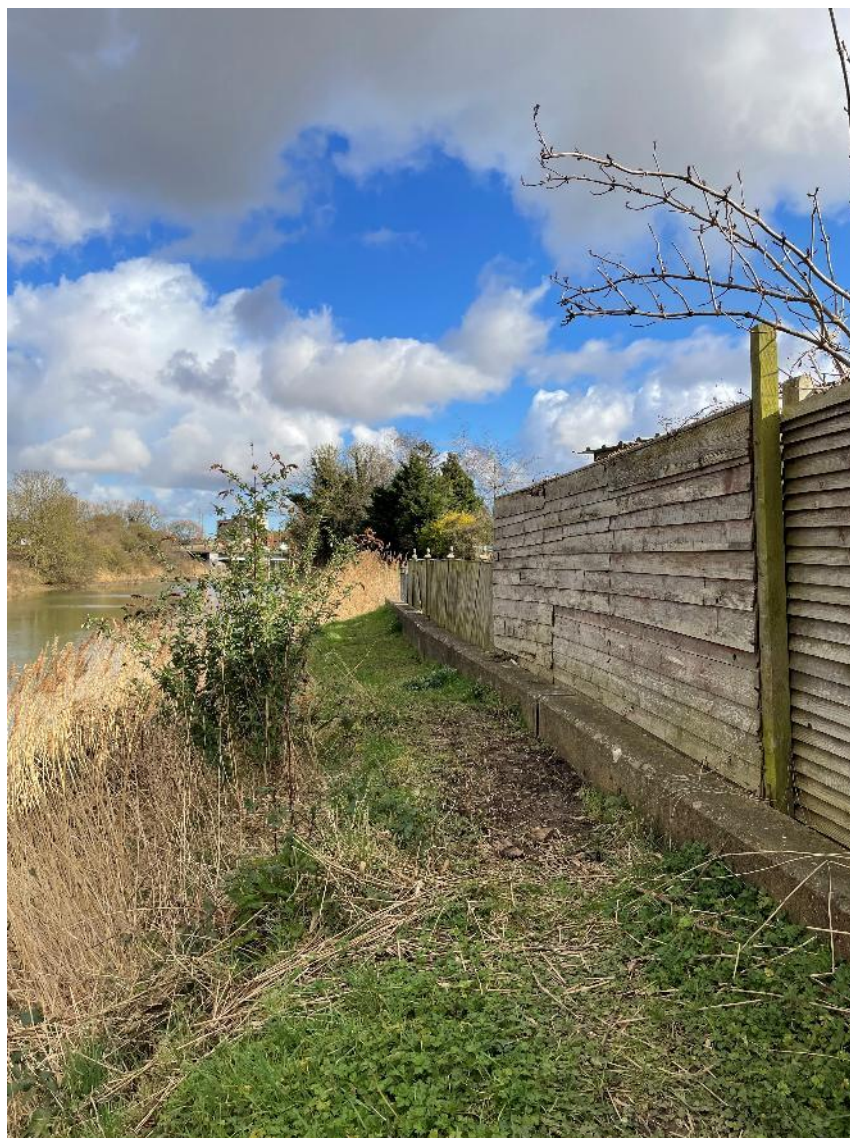
- Two sections of flood walls are located adjacent to Properties B to F and P to U, with effective crest levels between 2.80 and 2.88 mAOD (Photographs 1 to 3 in Appendix 7.3). These crest levels are validated by a post-incident flood wall survey undertaken by the EA as part of their review of the flood event (see Section 3.3). The defences are estimated to provide protection up to a 1 in 20 year (5% AEP) event and are recorded as having condition grades of 3 (‘fair’) to 4 (‘poor’);

*(Photograph 1 – Western section of EA flood wall structure along the southern bank of the SFFD; facing east)*

*(Photograph 2 – Western section of EA flood wall along the southern bank of the SFFD; facing west)*

*(Photograph 3 – Eastern section of EA flood wall along the southern bank of the SFFD; facing east)*

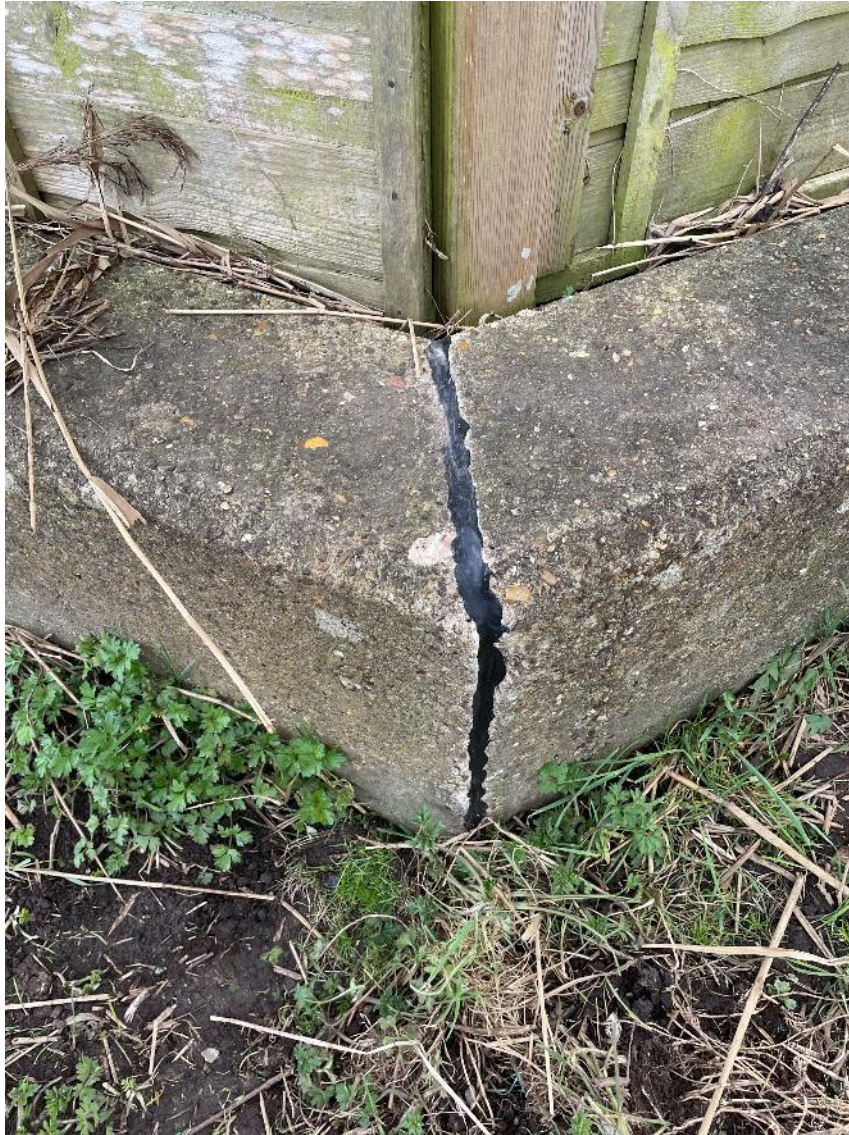
The EA held a routine inspection for the flood defences adjacent to the affected properties in June 2024, which indicated that there had been settlement and joint failures in these walls; these issues had not been resolved prior to the flood event. The EA also noted that seepage through the right bank of the SFFD has occurred since 2021, with standing water in gardens during periods of high river levels. As such the EA identified that seepage through the walls (as well as overtopping) likely occurred during the 06 January 2025 flood event. It should be noted that resealing works occurred between the flood event and prior to the Site visit for this S19 flood investigation (i.e. between mid-January and early March) (Photograph 4 in Appendix 7.3).

The EA indicated that settlement and joint failures had been reported within the wall sections in June 2024, but these had not been resolved by the January 2025 flood event. (The wall sections had been resealed between the flood event and Site visit in March 2025; see Photograph 4 in Appendix 7.3.).

*(Photograph 4 – Replaced seal on the eastern section of flood wall along the SFFD)*

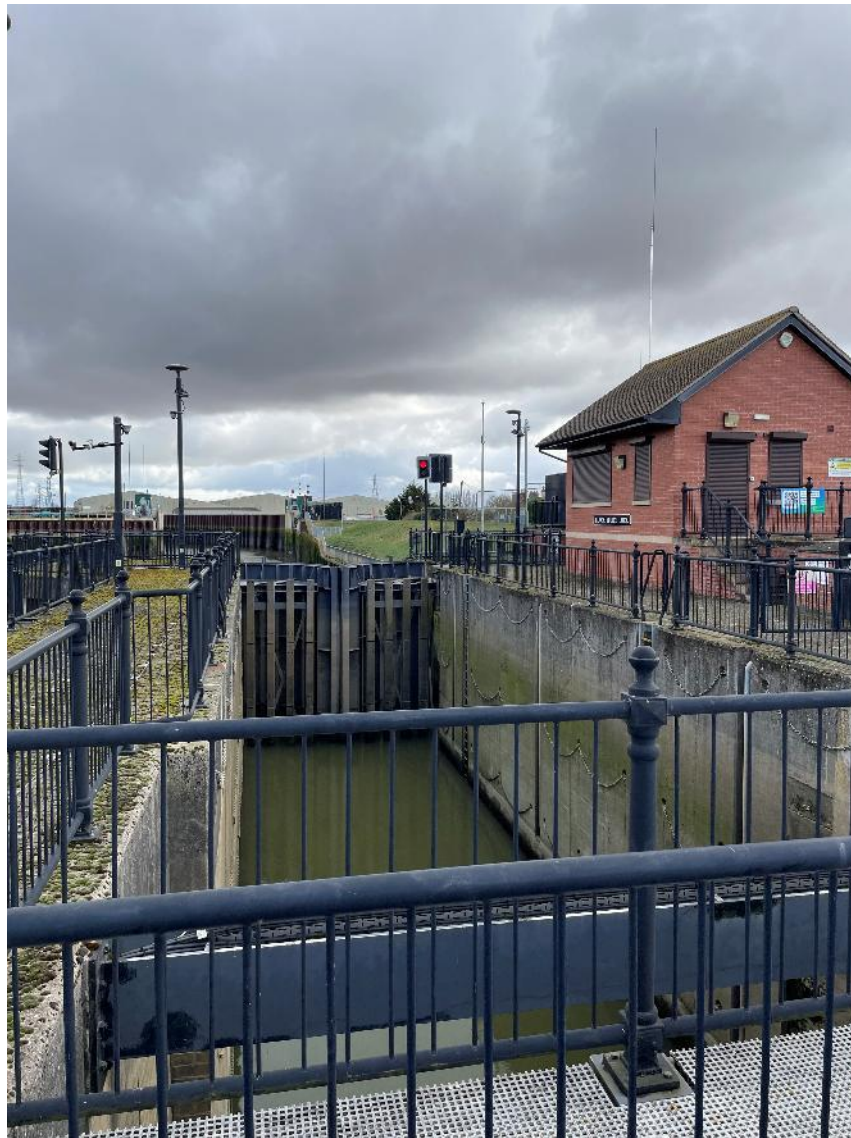
At present, flows from the SFFD are discharged into the Haven via two tidal sluices (Photograph 13 in Appendix 7.3). These sluices can discharge up to 45 m<sup>3</sup>/s each and are designed to operate automatically when the river is higher than the tidal level. During typical conditions, Gate 1 is used to discharge flows; during periods of high river flows, Gate 2 (which doubles as a navigational lock) is also used. £1 million was spent in inspecting and refurbishing the sluices so they were fit for purpose in 2020.

*(Photograph 13 – Sluice gate, also used as a navigational lock, at Black Sluice Complex; facing east)*
