S19-941

Wyberton West Road & Park Road, Boston

Section 19 Flood and Water
Management Act 2010

GeoSmart Information Ltd

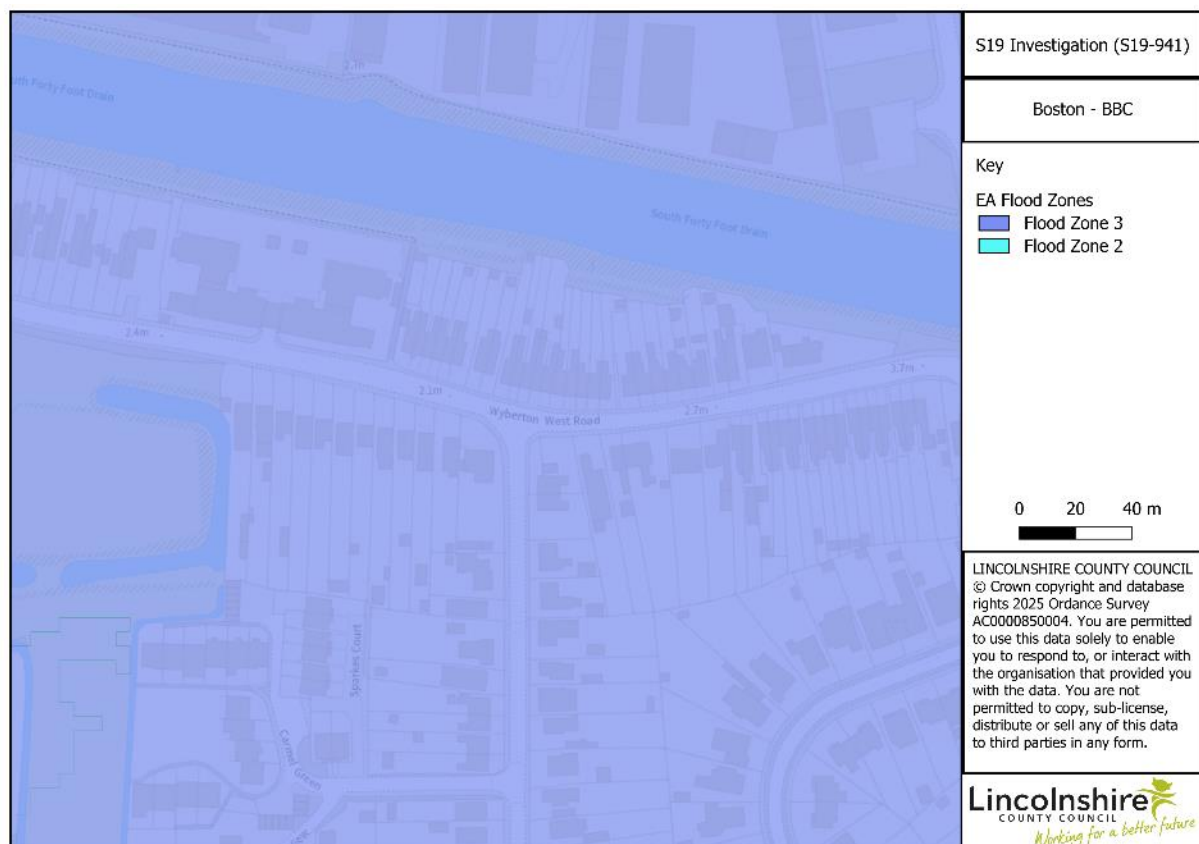
According to the EA's Flood Map for Planning Purposes, the properties are located in the EA's tidal Flood Zone 3, which indicates it has a High probability of tidal flooding (Figure 3).

(Figure 3 – Flood zone mapping for the properties and surrounding area)
