**S19-941**

**Wyberton West  
Road & Park Road,  
Boston**

Section 19 Flood and Water  
Management Act 2010

GeoSmart Information Ltd

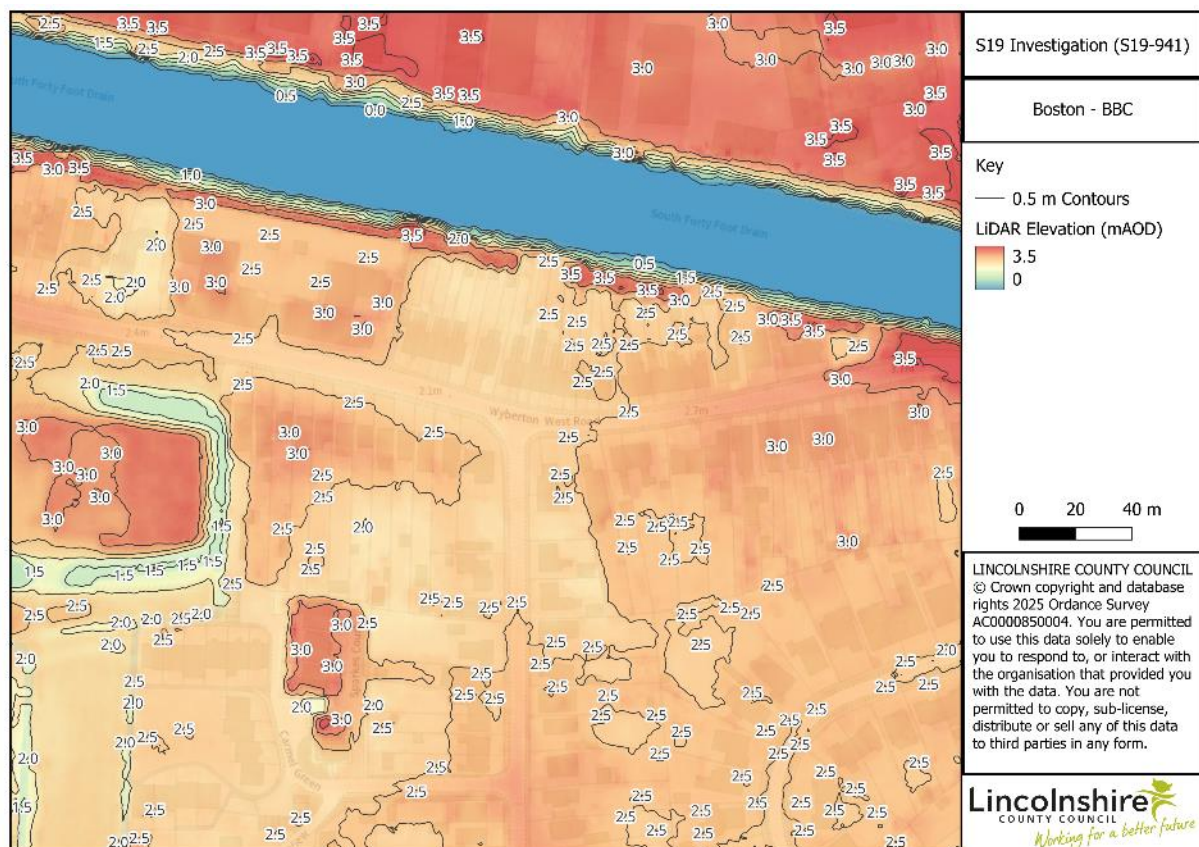
Properties A to AD are located in a local topographic low relative to the surrounding land (Figure 2). Wyberton West Road falls towards the junction with Park Road from both directions, while Park Road itself falls in a northerly direction. The affected properties are generally located on lower ground compared to adjacent unimpacted properties, with the highway falling towards Properties A to AD. Properties AF to AL are also noted to be located at a lower elevation than Park Road.

(Figure 2 – LiDAR elevation data for the affected area)

High ground associated with the southern bank of the SFFD is located along the northern boundary of the residential plots for Properties A to AD, with notable decreases in this level at Properties R to U and D to F.

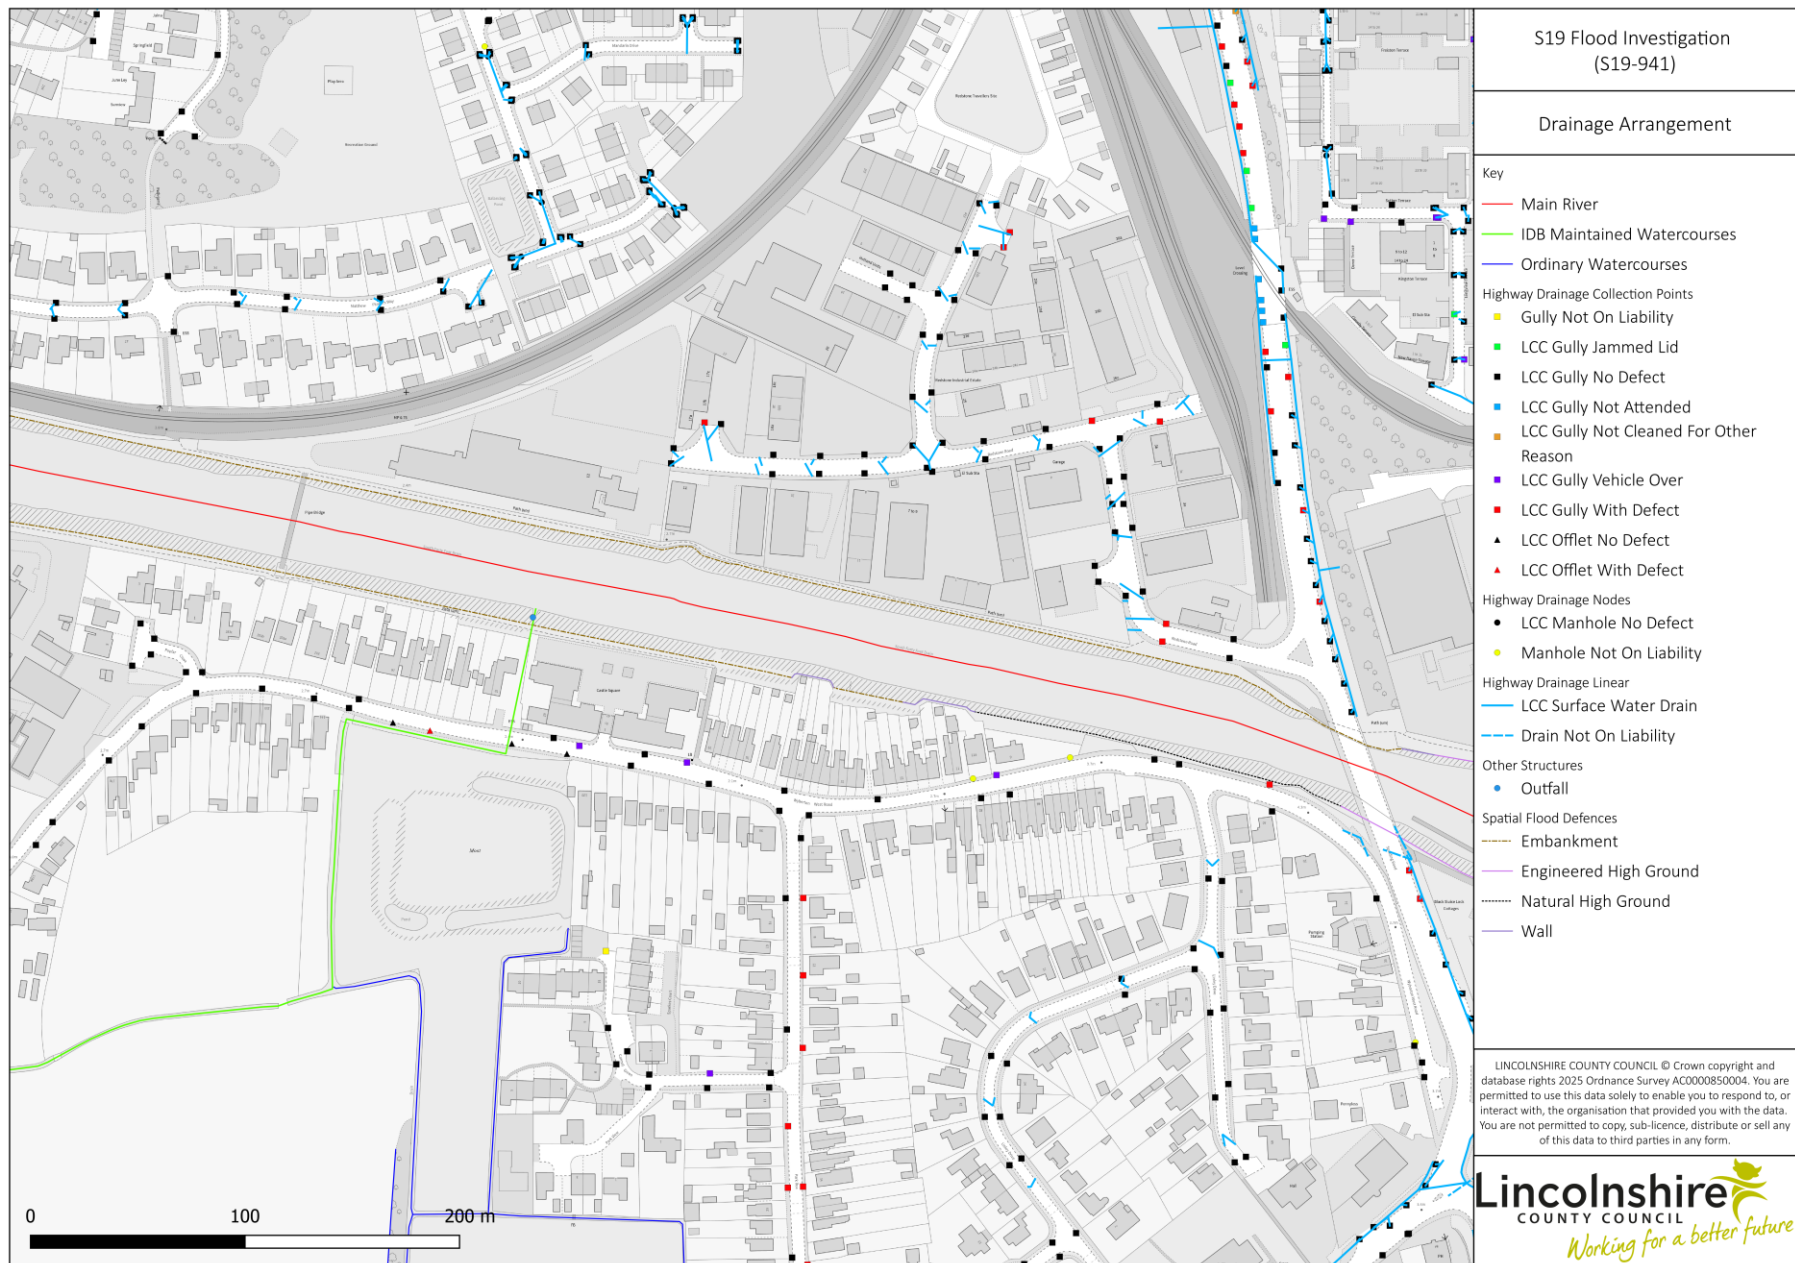
Consultants from GeoSmart Information Ltd visited the properties and surrounding area on 13 and 14 March 2025. As part of the visit, the drainage network on Wyberton West Road and Park Road was inspected, which confirmed that gullies and offlets are present along both highways in the same arrangement as included within LCC records.

A linear drain was observed along the kerb line between Properties O and T, which appeared blocked with silt in places (Photograph 7 in Appendix 7.3).

(Figure 4 - Known drainage assets included within LCC records along Wyberton West Road at the time of publication)

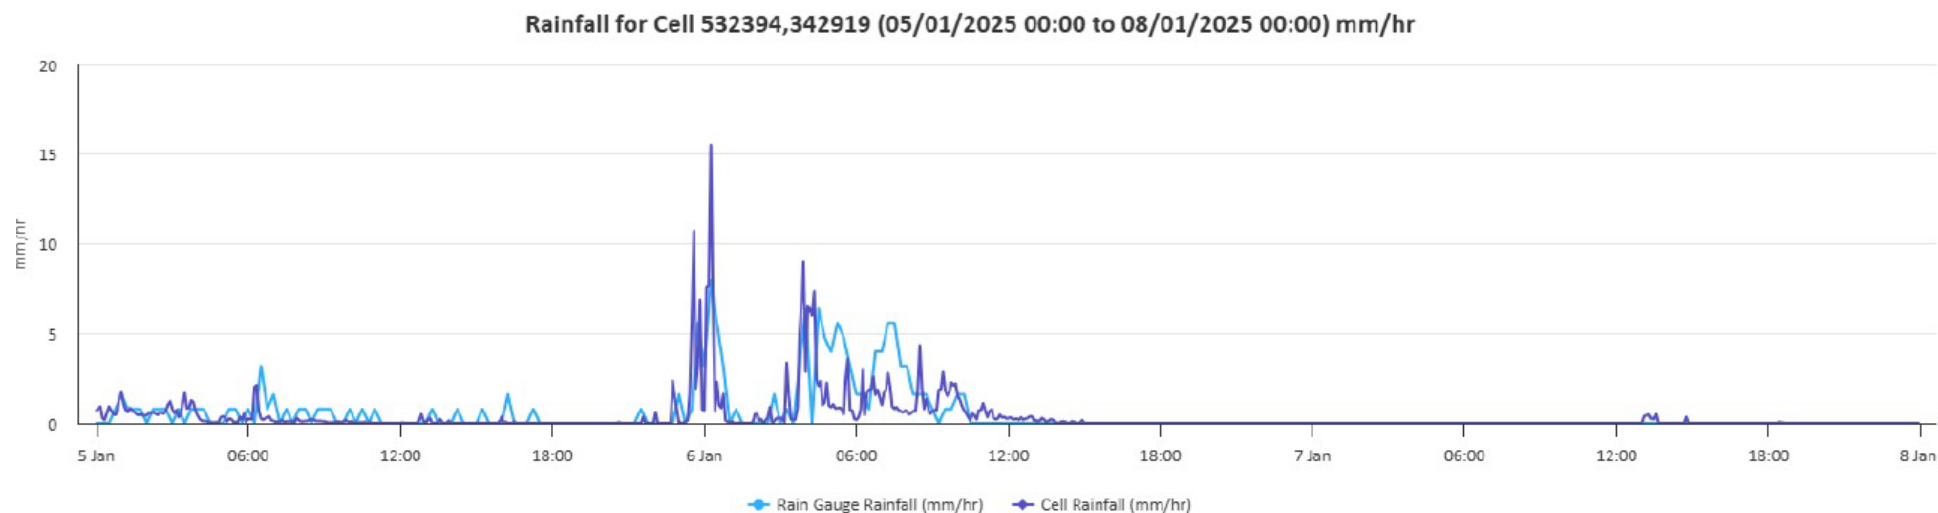
The closest available rainfall gauge is the Frampton Gauge (ref: E46361), c. 3.6 km south of the properties. Rainfall data from this gauge for 05 to 08 January 2025 has been considered as part of this investigation (Figure 5).

(Figure 5 – Rainfall intensities for Cell 532394, 342919, between 05 and 08 January 2025.)

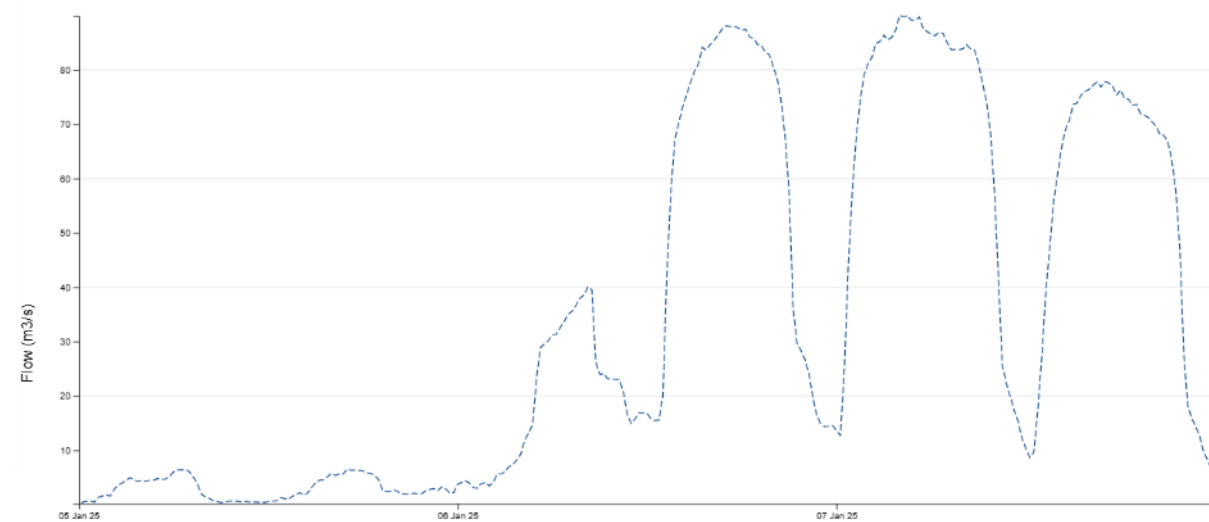
Flows began to increase in the early hours of 06 January 2025, peaking at 40 m<sup>3</sup>/s at 08:00 (flows were c. 3 m<sup>3</sup>/s at midnight) (Figure 6). The drop in flows (and lower rate of increase of flows) is noted to occur c. 0.5 hours after Gates 1 and 2 were fully opened (see Section 3.3). Flows reached a low of 15 m<sup>3</sup>/s at 11:00 then rose to 88 m<sup>3</sup>/s at 18:00, oscillating with the tide. Subsequent lows in the flow occurred at 23:00 on 06 January and 12:00 on 07 January, and highs were recorded at 04:00 and 16:00 on 07 January.

*(Figure 6 – River flows in the lower reaches of the SFFD between 05 and 08 January 2025, as measured at Hubberts Bridge Gauge.)*

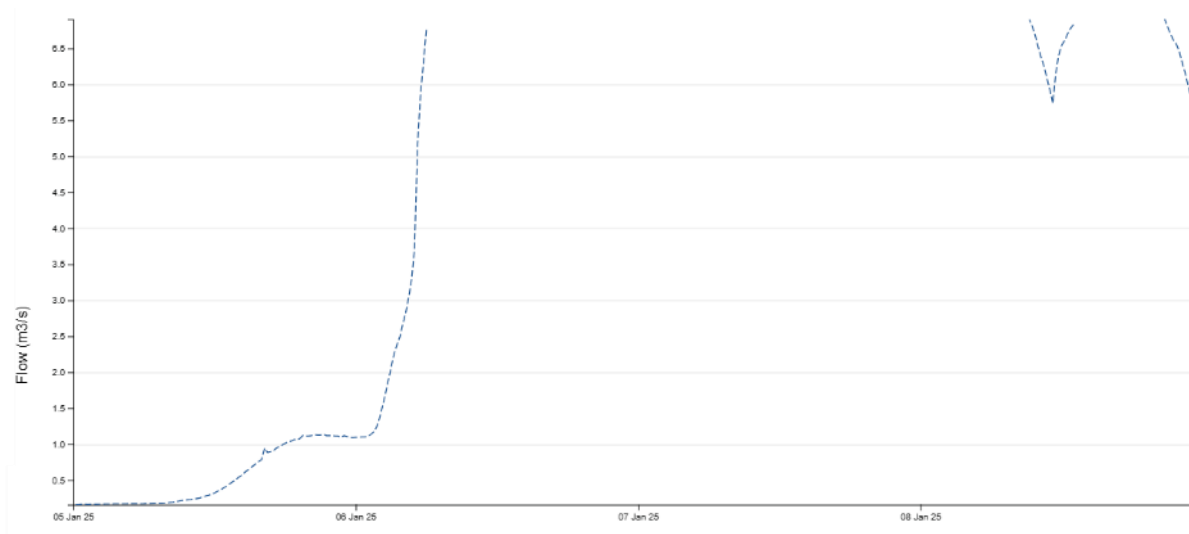
This indicates that flows in the Rippingale Running Dyke began to increase rapidly at 02:00 on 06 January; the peak flow cannot be identified as it exceeded the maximum measurable flow for this gauge (Figure 7). Flows fell within the recordable range briefly on 08 January and fell across 09 January.

*(Figure 7 – River flows at Rippingale Running Dyke, a tributary of the SFFD, between 05 and 08 January 2025, as measured at Rippingale Gauge.)*

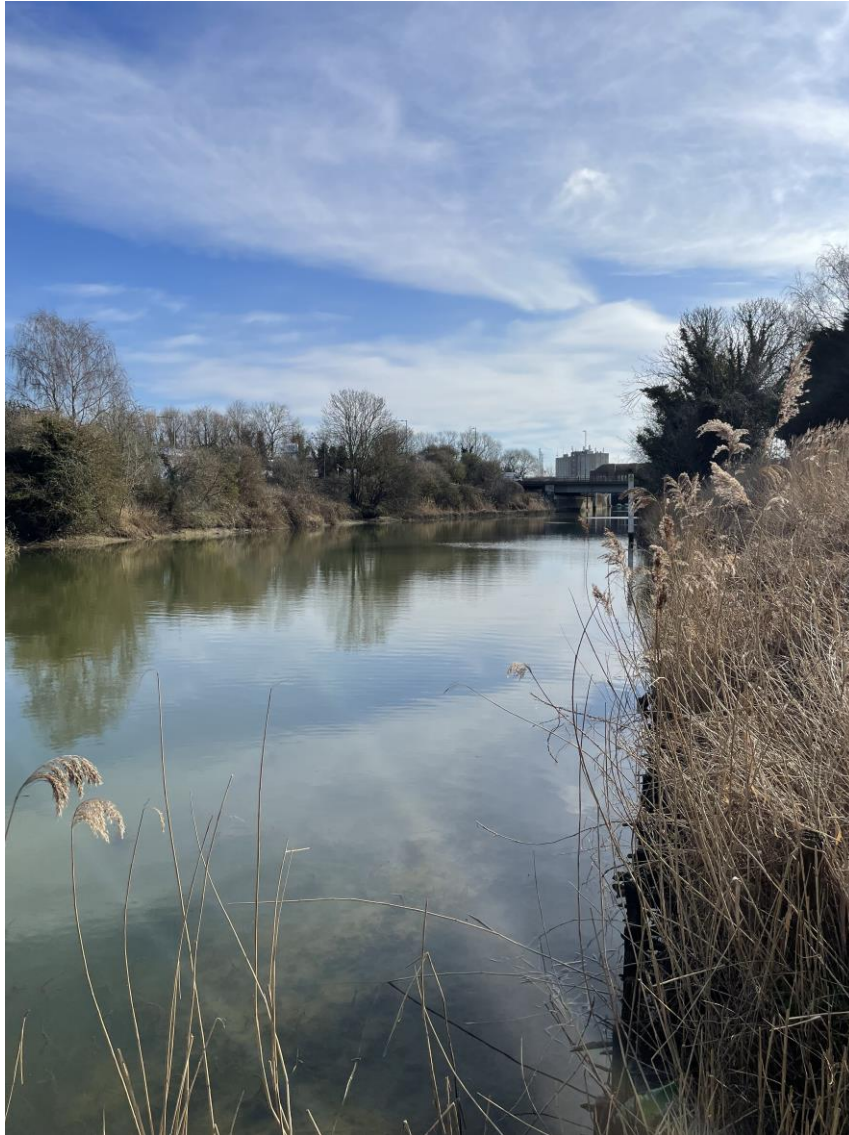
*(Photograph 11 – South Forty Foot Drain, as viewed during the Site visit downstream of the properties; facing north-east)*

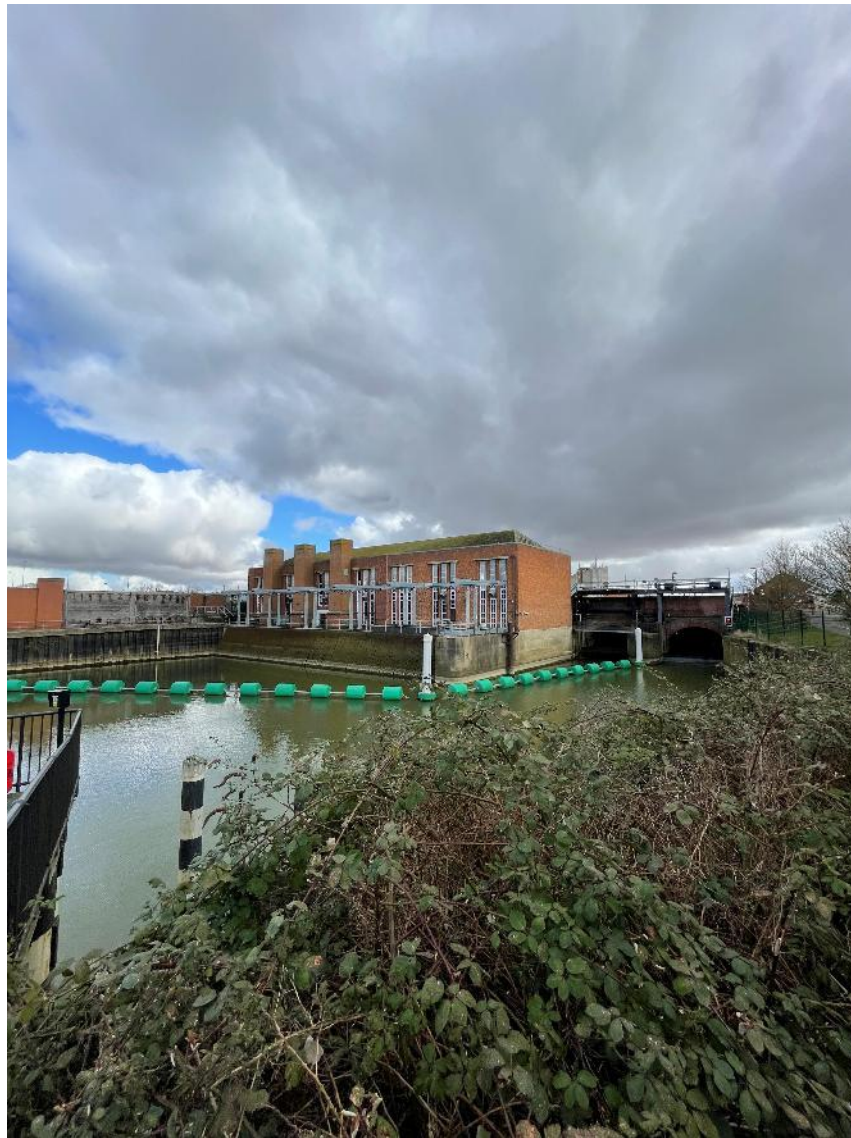
The BSPS was constructed in 1946 with three pumps; two further pumps were installed in 1966 (Photograph 12 in Appendix 7.3). The BSPS was used to discharge flows from the SFFD during periods where extreme flows coincide with high tide and was operated by the EA.

*(Photograph 12 – Black Sluice Pumping Station, with sluice gates to the right; facing north-east)*
